Special Report 150

CAMP CENTURY REVISITED A PICTORIAL VIEW-JUNE 1969

Austin Kovacs

July 1970

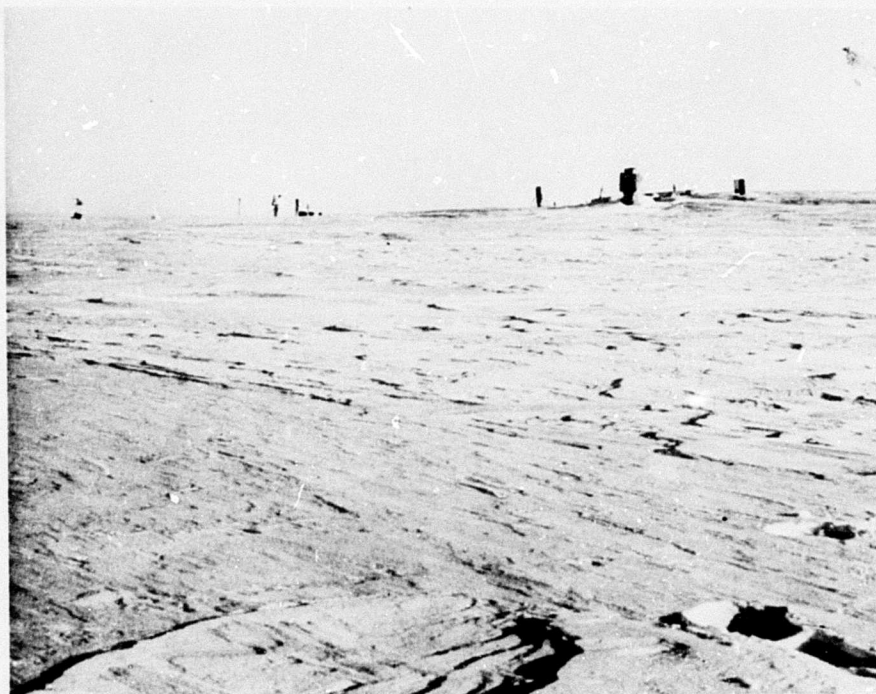
Figure 7. Area of the 1966 surface camp. This camp consisted of three wanigan trains and a T-5 building.

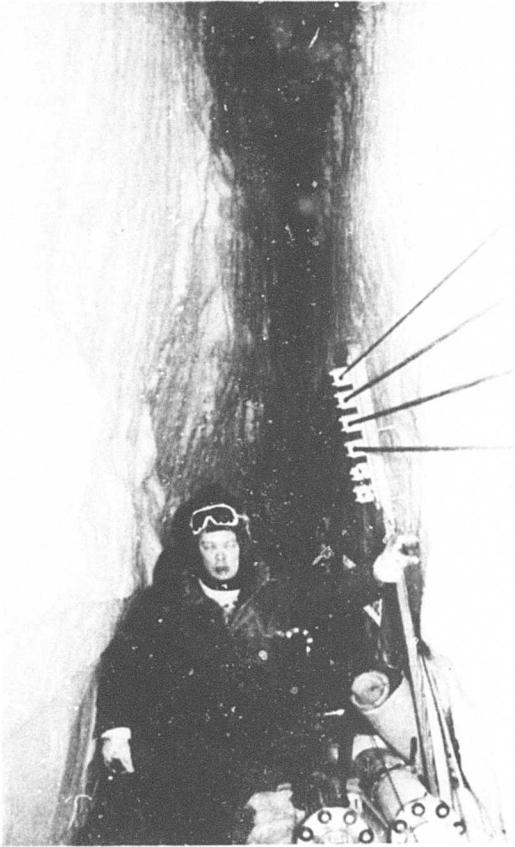
Figure 11. The glycol trench, once 9 ft wide, has undergone considerable deformation. Heat which once escaped from the glycol pipeline leading from the reactor to the glycol well and residual heat within the well increased the temperature of the surrounding snow. This in turn increased the deformation rate of the snow and accelerated trench closure.

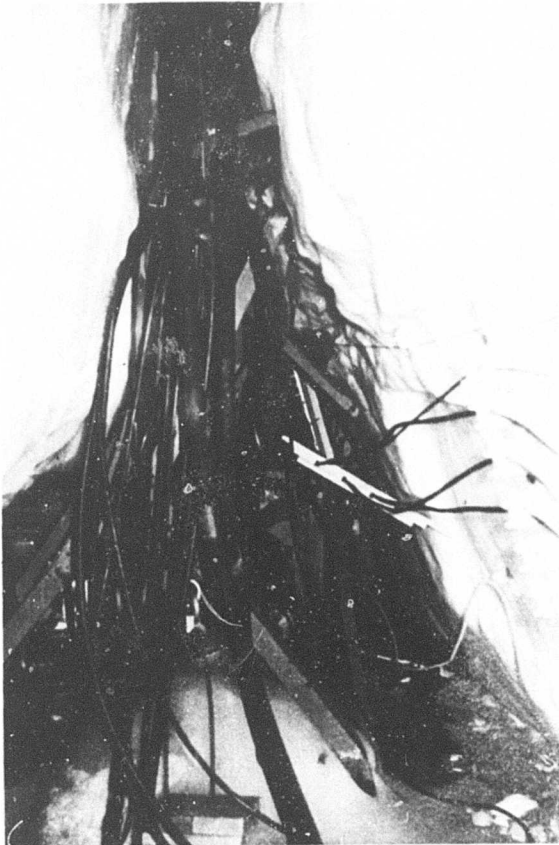
Figure 12. Snow deformation crushes the derrick over the glycol well.

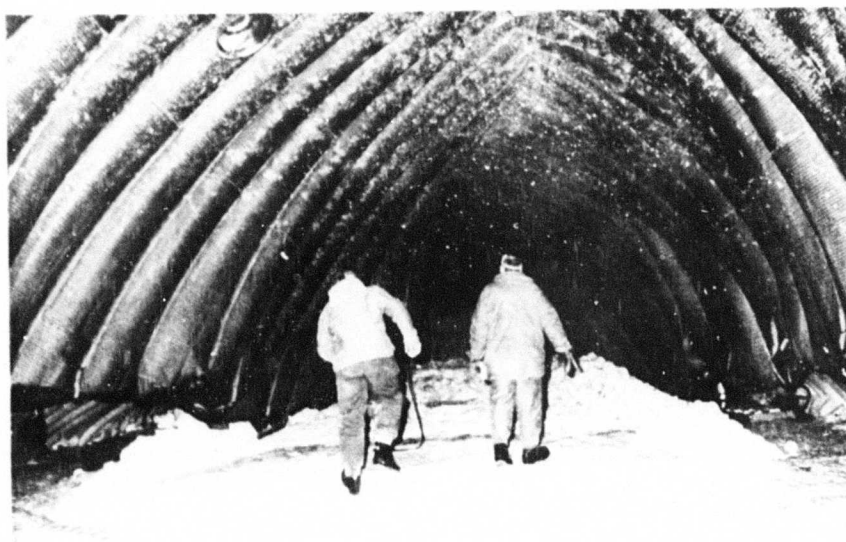
Figure 86. Arch deformation, Trench 21.

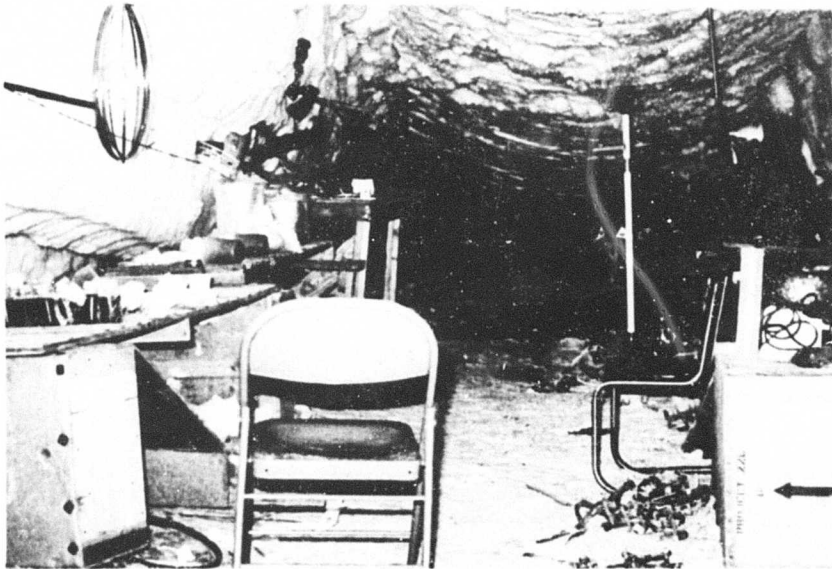
Figure 91. Roof sags most where the inclined drift and railroad trench intersect.
